## Insurance survey report of “xxx” a Rampage 24, 1987

Discovery Marine Surveys®

## Condition and Value Marine Survey Report

2014-xxx

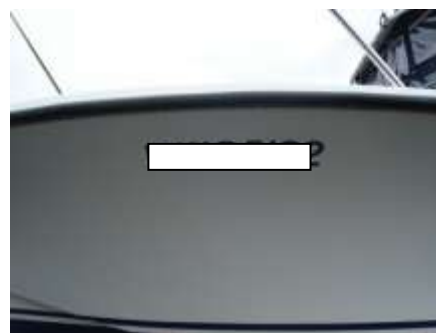
### **Licence**

bbb
