Pre-purchase survey of Boston Whaler Walkaround 25, 1990

Discovery Marine Surveys®

Pre-purchase Marine Survey Report

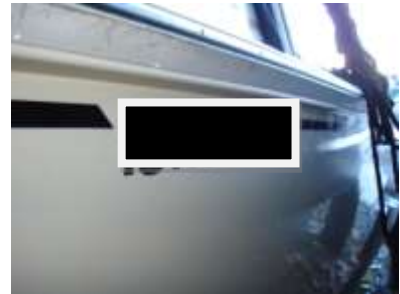
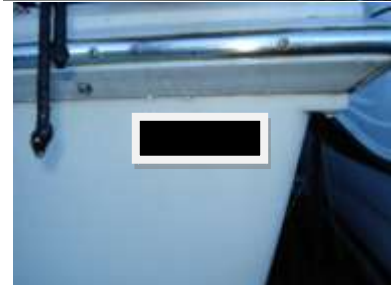
Joint was inspected where possible and showed no signs of separation no cracks at the joint. The rub-rail is in above average condition for a vessel this age. See picture of HIN & Licence. The topsides were visually inspected, no hull deformations were noticed, and no cracks. There was minimal wear for a vessel of this age. Moisture metre readings were consistent over the topsides returning low moisture levels.

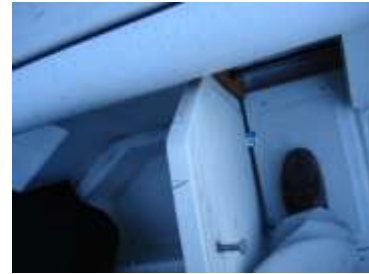
Fore deck and cleats

The deck is frp with some non-skid, in above average condition. On the bow section a small bowsprit has a bow-roller with anchor followed by a Horizon 600 series windlass. Anchor locker on centered the lid cannot be secured in close position. Stainless steel rail with stainless steel stanchions from bow to mid deck, are secure and in good condition, fender holders are installed on both sides in serviceable condition. Mooring cleats are located port and starboard on the bow and the stern, are secure and in serviceable condition. The aluminum windscreen frames are in serviceable condition and showed neither leaks nor cracks. A bench with a cushion is aft of the windlass in above average condition; cushion is reported as re-upholstered in 2009. A large hatch is located on top of the cuddy cabin in good condition, no signs of leaks were noticed. Two horns are located on starboard side below the windscreen, were not tested. Two opening ports located on port and starboard are in good condition and showed no leaks. The non-skid, passageway and deck are in above average condition.

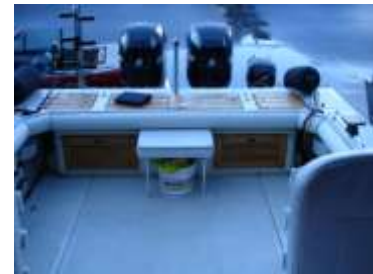
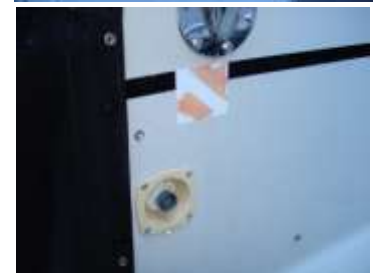
Aft deck

The aft deck is a large open concept with a deck chair and small table in good condition. The deck has inspection holes for the fuel located under the deck and for the fuel filler hoses on port and starboard. Fishing rod holders and filler caps are located around the aft-deck secure and in serviceable condition. Wells are located on port and starboard and in good condition. Pump for the live-bait well did not work. Stainless steel grab-rails are located port and starboard are secure and in good condition. The aft deck has cushioned knee-rail installed all around in good condition. The deck shows no cracks or dings in the fibreglass, the non-skid is in good condition, above average. Wash down connection is located on starboard side, reported in working condition; a shore water connection is located nearby reported as never used. Lockable drawers with wooden face are located under the captain's seat; wood is in above average condition.

- C1. The diver ladder needs a retaining pin or some form of attachment to allow it to stay up out of the water.
- C2. The pump for live-bait could be replace.

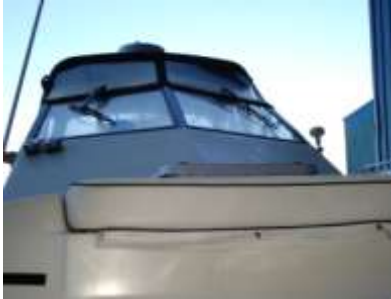
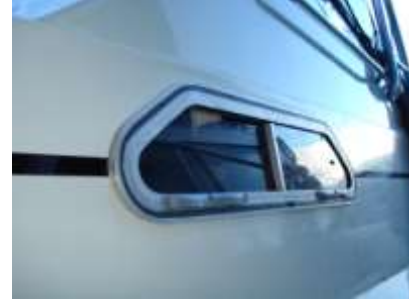
Cabin

The cabin has port and starboard opening ports and a large opening hatch centerline forward. The fibreglass is in above average condition for a vessel this age. Entrance for the cabin is centerline from the helm station via accordion type wooden doors and sliding hatch in above average condition.

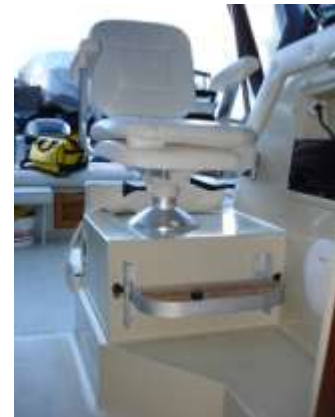
Helm station

From the aft-deck up one step there is the captain seat on starboard and first mate on port with aluminum foot rests, upgrades from originals, in above average condition. Helm to starboard with original equipment and a complement of newer equipment. All equipment that was tested was in working condition. Equipment that was not tested is reported as in working order. The windscreen has no cracks seals appear in good condition and no water stain was noticed. No cracks in the fiberglass. The stainless steel arch is solidly mounted port and starboard to the lower part of the helm station and supports the Garmin enclosed array type radar. Windshield wipers appear in working order. The helm operated smoothly, no sign of fluid leaks and hoses appear in good condition. Mercury throttle controls at the helm for main engines and separate throttle control to starboard of helm's seat for auxiliary engine. All three engines are linked to allow operation from the helm. The helm console tilts forward to provide access to the wiring and hydraulic system, all clean and in good condition. Storage bins are inserted in the helm station on port and starboard, in serviceable condition. Radar, VHF antennas are attached to the helm station fiberglass portion, secured and good condition. Grab rails are secured on port and starboard. A Bimini is installed over the helm station with a stainless steel frame, the bimini extends forward to attach itself to the top of the wind-screen and aft to create full enclosure, In near new condition. Other reported canvas, purchased and reported in same condition

as bimini are: Stern cover zips into top of Bimini and stretches to cover the entire back of the helm station (this was on the boat at time of survey). Front cover fits over the entire cockpit Walkaround windows and cockpit Bimini. Mooring Covers, not sighted. **See comment C3, C4, C5**

- C3. The face plate on the auxiliary throttle control has come loose and could be re-attached.
- C4. Part of the panelling on starboard near the captain's seat has separated from the helm's station fibreglass and could be re-attached.

- C5. Some wiring is unsupported and should be secured, as per ABYC standards.
- C6. Wiring connection should have heat-shrink over them.
- C7. Cushion could be cleaned as some small stains were noticed.

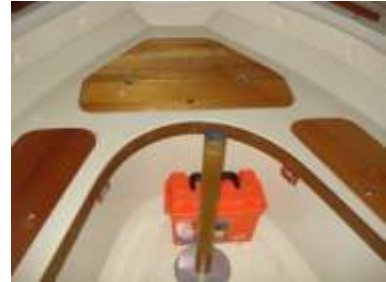
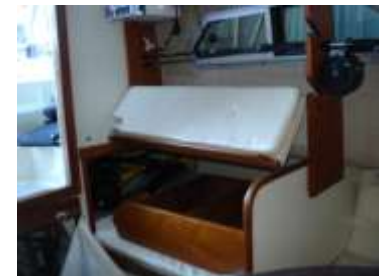
General comment

The interior is a complement of wood, fibreglass and carpeting all in serviceable condition. Entrance is centerline from helm station, a small three steps removable teak ladder provide easy access. Immediately to starboard are the electrical panels and the head, to port is a convertible settee and birth. Moving forward is the dinette area centerline, a 'U' shaped settee with a removable round table. The 'U' shaped settee converts into the v-birth. Under the cushions storage area is available. The lids are teak and in above average condition. No signs of leaks or water intrusion were noticed. All materials are in good condition. A wood trim around the 'U' shaped settee, apparently to prevent the cushions from slipping has separated from the fibreglass. The second HIN number is located in the starboard storage locker of the 'U' shaped settee. A GFCI AC outlet is located immediately to port upon entering the cabin.

- C8. The removable steps are difficult to operate and the locking latch/screw does not meet the threaded fitting properly.
- C9. The wood trim around the 'U' shaped settee is/was secured with screws, a better system would be bolts with some form of backing plated to prevent the fibreglass from cracking.

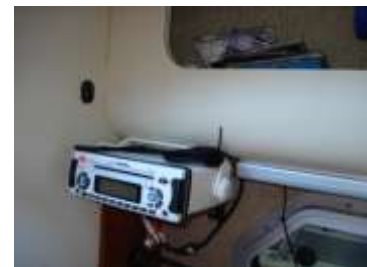
Entertainment system.

MCD 4115 radio with CD player located port side in the cabin, Bose speakers located near helm station and aft of aft-deck, powered-up. See aft deck pictures.

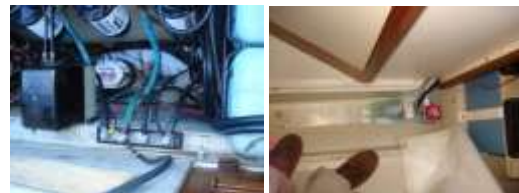
Bilge & bilge pumps

The boat has two bilge pumps, the pump in the bilge located in the cabin is a Rule 1000, and the one at the stern is a Rule 1500. Both in working order.
