Insurance (C&V) survey of C&C 44

'Boat name'

Discovery Marine Surveys®

C&V Marine Survey Report

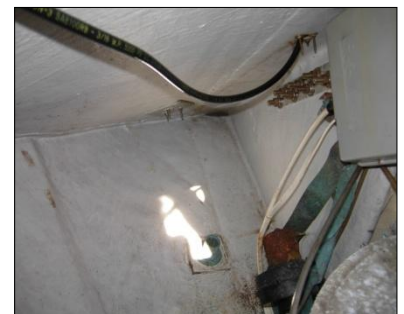
Some chips were noticed on the gelcoat on the lower part of the transom (**see comment 1**).

An abandoned through hull was located on the starboard side of the transom near the steering quadrant (**see comment 2**).

Comment 2: The abandoned through hull in the transom should be plugged or a ball valve installed and capped.

Comment 1: Some chips on the transom gel coat could be repaired to prevent moisture penetration and to enhance appearance of vessel.

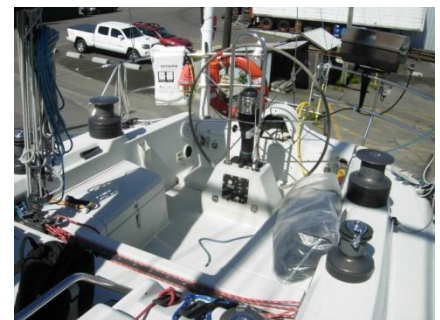
A sliding acrylic companionway hatch & acrylic washboard both with teak trims, stainless

Steel companionway grab rails, locker hatches with miscellaneous sailing gear, steering pedestal all secure and in good order (**comment 4**).

Comment 4: It is suggested to refinish the teak on the companionway hatch and washboard for appearance and safety.

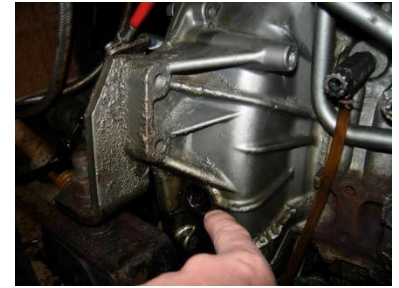
The transmission was visually inspected and appears in good condition; at the time of inspection it was missing a pressure cap (**comment 5**).

Comment 5: It is recommended that a cap be installed on the transmission inspection hole.

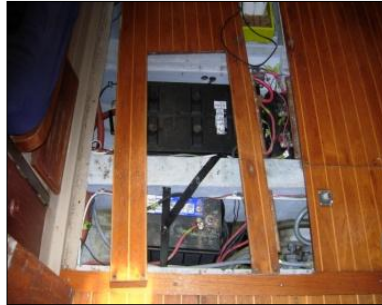
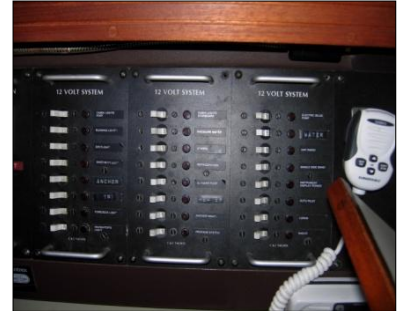
Three batteries were located under the main cabin floor (**comment 11**).

Comment 11: The battery located under the main cabin floor should be secured (usually done with straps). The cabin sole needs to be secured. Rubber caps on the positive terminals of all batteries as safety protection should be installed as per ABYC.

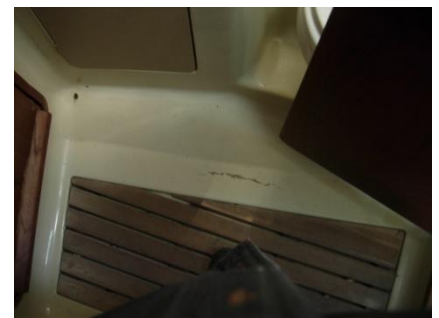
Comment 13: There is a crack in the fibreglass floor of the aft head, it is not a structural issue but it should be addressed to avoid possible foot injury.
