# Pre-purchase survey of Tayana 37, 2005

Tayana 37

## Discovery Marine Surveys®

January 29, 2014  
DISCOVERYMARINESURVEYS.COM  
604 318-1402  
Vancouver, B.C.  
Canada

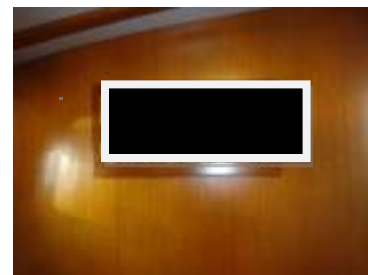
### Registration

The vessel registration information was not provided.  
N.R.T.  
Reg.  
**See comment A1.**

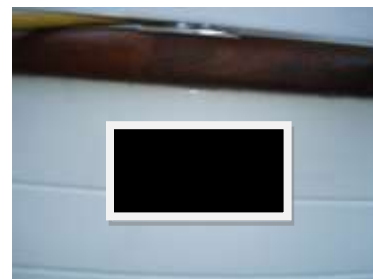
### HIN/MIC

HIN number as found on the top starboard side of transom.

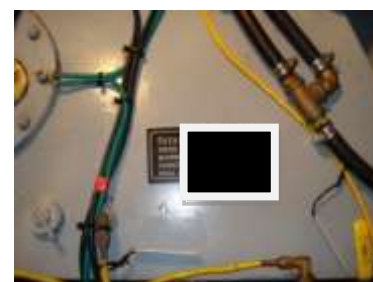
### Manufacturer's plate

Located on the aft fuel tank

Model no. T37  
Serial no. xxx

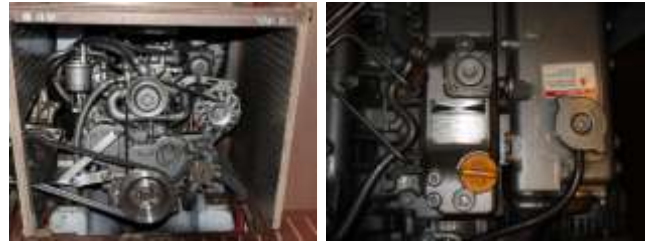
Engine no. E02949

Engine hours 610

Engine is located under the companionway steps. The engine compartment is lined with aluminium lined cork sound insulation barrier in serviceable condition, above average installation. The engine was clean and the engine area was clean. The oil is clean and the oil filter appears recent. Original equipment water strainer was sighted. The alternator belt is in good condition but loose. The engine is accessible by removing the companionway steps and by removing miscellaneous hatch covers from the sea birth and the aft-cockpit, through the port locker. The oil pan appears in good condition no leak was sighted or felt. The compressor for the freezer/fridge is located to starboard with double belts and double, apparently custom made, stainless steel pulleys. Double belts appear in serviceable condition and are tensioned properly. The impellor cover has been replaced by an aftermarket “speedseal” with fastening that can be tighten and loosen by hand. The original cover was noticed in the aft cockpit locker. The silencer box is glassed and a flex hose installed. All hoses appear in serviceable condition. Coolant level was low in the overflow tank. The engine after warm up was push to about 3200rpm pushing the vessel at approximately 7.5 knots, the temperature remained stable no vibrations were noticed or felt. The engine blower is in serviceable condition.

**See comment B4, C13.**

C13. Some marine growth was seen floating within the strainer during operation. Recommend cleaning the strainer. This is valid for all strainers in the vessel.
