Pre-purchase survey report, 'xyz' 2001 Navigator 61.

Discovery Marine Surveys report no. 2016-113a. Report prepared for: Mr. John Doe	Vancouver November 23, 2016.
Fair market value

2016-113a Date of Survey November 16, 2016 Commissioned by Mr. Address E-mail Telephone Vessel condition (summary)

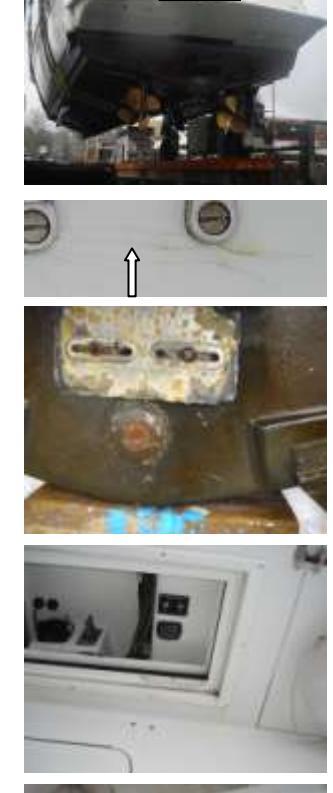
The transom has an integrated swim platform in serviceable condition. The access gates are port and starboard, the hinges appear to be in serviceable condition, the pivoting bolt lock is secure the finish is in average condition. Cleats on port and starboard appear in serviceable condition, some stress hairline cracks were noticed on port side. A diver anode is located on centreline under the swim platform, approximately 20% depleted the anode has a layer of white soft material indicating that it might not be fully active. Trim tab anodes appear in serviceable condition. Two trim tabs are installed and secure, the Bennett type actuators are secure and the hoses appear in serviceable condition. The attachment points between the tabs and the actuators appear secure and in serviceable condition. The fluid canister located under the aft deck have proper amount of fluid, all connection appear dry. Exhaust tubes were visually inspected and the joints from tube to hose appear in serviceable condition no hairline cracks in the hoses were noticed. A re-boarding ladder, deployable from the water is not installed. Three underwater LED lights are

secure under the swim platform. The transom has a washdown station on port side in serviceable condition. The Transom has some storage space the emergency engine shut downs are located in that compartment. Port side has a fitting to plug-in to shore pressure water. **See comment B2, C1.**

B2. The underwater LEDs were tested only the port side is working. Anodes should be inspected regularly and replaced as necessary the anodes currently used are zincs adequate for salt water. The galvanic connection between the anodes and the part they are protecting should be inspected, the metal to metal connection should be cleaned to insure proper conductivity. A re-boarding ladder deployable from the water should be installed (in can be installed under the swim platform) this is an ABYC requirement.

C1. The cracks in the gelcoat should be opened and new gelcoat should be applied. Try colour matching in a less obvious location first.

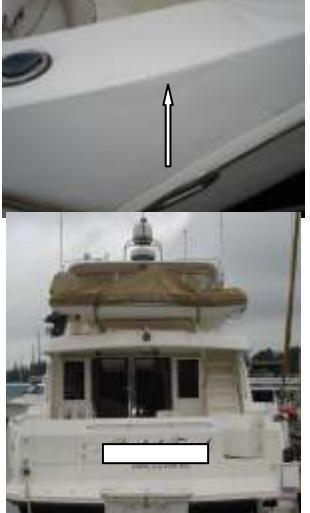
A staircase to the fly bridge is to starboard. Large sliding glass doors provide access to the main cabin, the door functioned as expected with no damage to the glass, the frame or the track noticed. The aft deck has one hatch to provide access to the standing headroom engine room. The hatch has flush latch and hinges a hydraulic piston holds the hatch in the open position functioned as expected. The area was clean and dry. Some small hairline crack on the gunwale was noticed with a gelcoat repair the colour match is unfortunate on that repair. The sliding hatch to access the fly bridge was difficult to operate and growth of some sort was noticed on the track. The enclosure that separates the dingy storage area from the fly bridge does not appear to allow someone opening the enclosure from the dingy storage area side. **See comment C2.**

C2. Shore pressure water fittings have fallen out of fashion for the very good reason that if the boat water system is pressurized by the shore water supply the water pressure is usually much higher than under the ship's system, in the event of the failure of a component of the vessel's water system the vessel will be filled with an endless supply of fresh, potable water. If the fitting is to be used at all make certain that the latest safest automatic shutoff system is installed and never leave the vessel unattended with the shore water pressure valve at the dock in the open position.

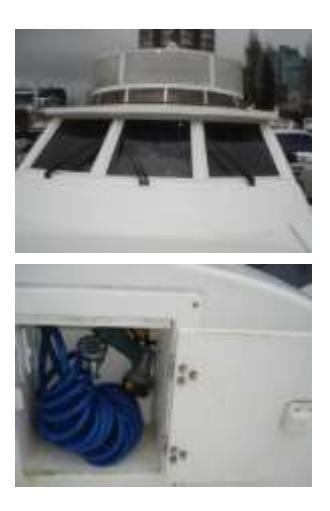
Bow roller on bowsprit with electric windlass. Hatch appears in serviceable condition, some signs of leaks were noticed from the forward cabin. Cleats are secure, the stainless steel pulpit and stanchions appear secure no cracks were noticed in the gel-coat. The gel-coat and non-skid are in above average condition. Moisture metre readings with an Electrophysics GRP200 moisture meter, could not be taken due inclement weather. The deck did not appear to flex under weight of the surveyor. The side deck appears in serviceable condition. The windscreen glass panels have rubber seals in above average condition, the frame for the pilot house are in above average condition. The windscreen wipers operated properly. Wash down locker located at the bow appears in serviceable condition. Windscreen 'Lexan' type glass panels for the fly bridge appear in serviceable condition.

C3. The gel-coat on the cabin top and other non-walking areas could be polished with a cutpaste like 3M finesse or other similar product, two or three coats of hard wax could be applied for UV protection and a few coats of liquid wax could then be applied for shine and as sacrificial coats. This enhances the beauty of the vessel but also protects the gel-coat from oxidization. The leak from the 'Bomar' type hatch should be investigated further and the situation remedied.

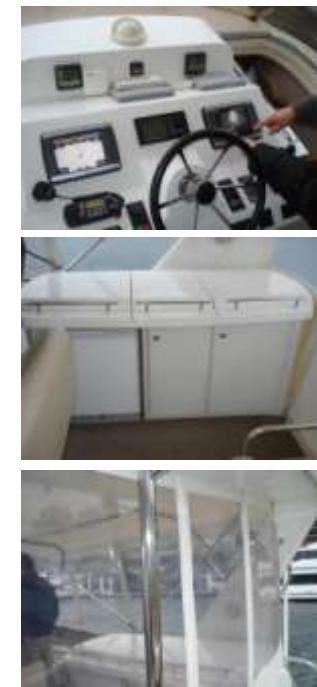
Access is from a staircase in the pilot house and from a stair case on the aftdeck. These appear secure and in serviceable condition, a large hatch gives access to the flybridge area from the pilot house. A large sitting area and the helm, with full instrumentation appear in serviceable condition. The sitting area doubles as storage space. The cushions are made with foam covered with a simile leather material in above average condition. No crazing on the splash guard windscreen was noticed. All courtesy lights appear in serviceable condition. The helm operates the rudders, throttle and transmission. Instruments are in working order rpm does indicate the same information from the main helm. The area has a Sunbrella type bimini in above average condition, the frames are stainless steel and appear secure, no stress cracks were noticed at the attachment points. A small bar area is located to starboard with bar fridge in serviceable condition a bar sink with cold pressure water in serviceable condition a hot plate is reported in serviceable condition. A R.I.B. dingy with outboard is secure on the aft section with an electric Brower davit, both are reported in serviceable condition but were not tested. The cover of the dingy is in poor condition. The dingy was not part of the survey and the information is provided as courtesy. See comment C4.

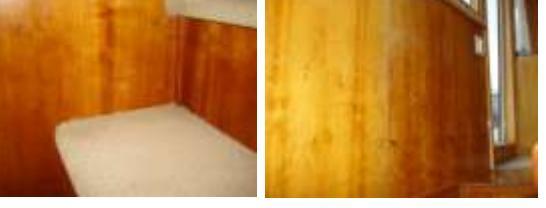
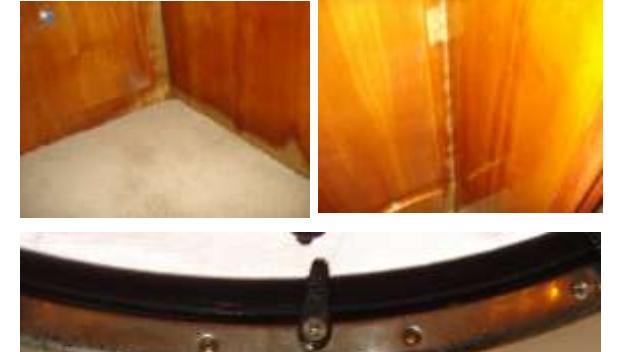
The forward cabin has a queen size island type bed. Hanging lockers are clean with cedar panelling, in above average condition. All drawers operated properly with no sticking or signs of movement. Under the mattress the area that was accessible was clean and dry, no water was found in the bilge, limited access for inspection in that area. Port openings appear in serviceable condition, no signs of corrosion or water ingress around the frame of the hatches was noticed with the exception of one small sign of corrosion on one of the eye shape port. A door to port gives access to the head with separate shower, sink and head. A panel under the mattress provides access to the hull and the bow-thruster, the area was clean and dry. A panel at the head of the bed can be lifted to access the chain locker. Some water damage was noticed behind the door, this appears to be and older

condition during the survey the area remained dry. A small flat panel TV powered-up and is located to port the installation prevents one of the cabinet's doors from opening.

C5. The wheel helm custom box should be clamped, re-glued and revarnished. The chrome could be cleaned with product like 'Never Dull' this to prevent pitting and the need for re-finishing. These two conditions are likely due to the boat not being used and humidity level getting high in the vessel. It is the opinion of your surveyor that the vessel should go through a period of time with heathers/ air conditioning and possible dehumidifier running to dry the wood paneling and accessories as well as carpeting and furniture.

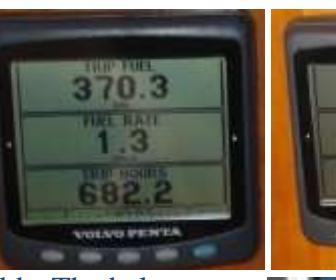
Engine mounts are original Volvo and appear in serviceable condition, they mounted on the strigners, no cracks or damage to the mounts the rubber isolators or the frp supports were noticed. No corrosion was noticed. The stringers around the engines were tapped with a 12oz phelonic hammer and returned clear crisp sound, they were also tested with an Electrophysics GRP200 moisture meter, the readings were low.
