Insurance (C&V) survey of C&C 44

'Boat name'

Discovery Marine Surveys®

C&V Marine Survey Report

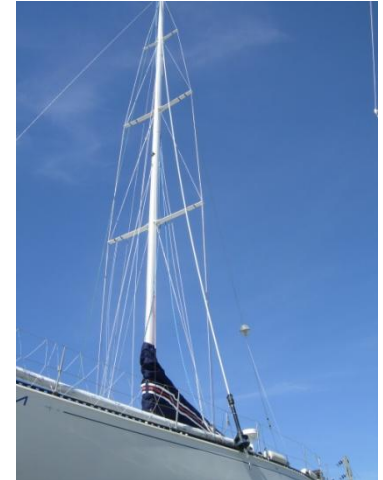
Mast(s)

The mast was inspected from deck level and appears in good condition. The mast is anodized aluminum fitted with three spreaders. The mast-to-boom gooseneck connection appears in good condition with no stress or hair-line cracks all fittings appear solid and secure. The owner report that a complete inspection and repair of the mast was also completed in 2011.

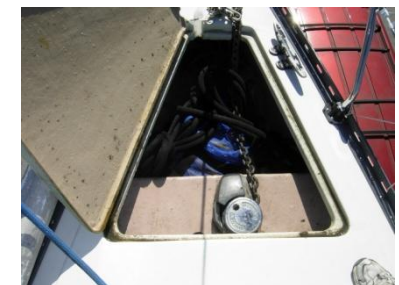
Rode

Approximately 50ft of chain and 300 ft of rode and approximately 50ft of chain and 150 of rode.
